Sacramento River Watershed Conference

Iron Mountain Mine

October 27- 28, 2005

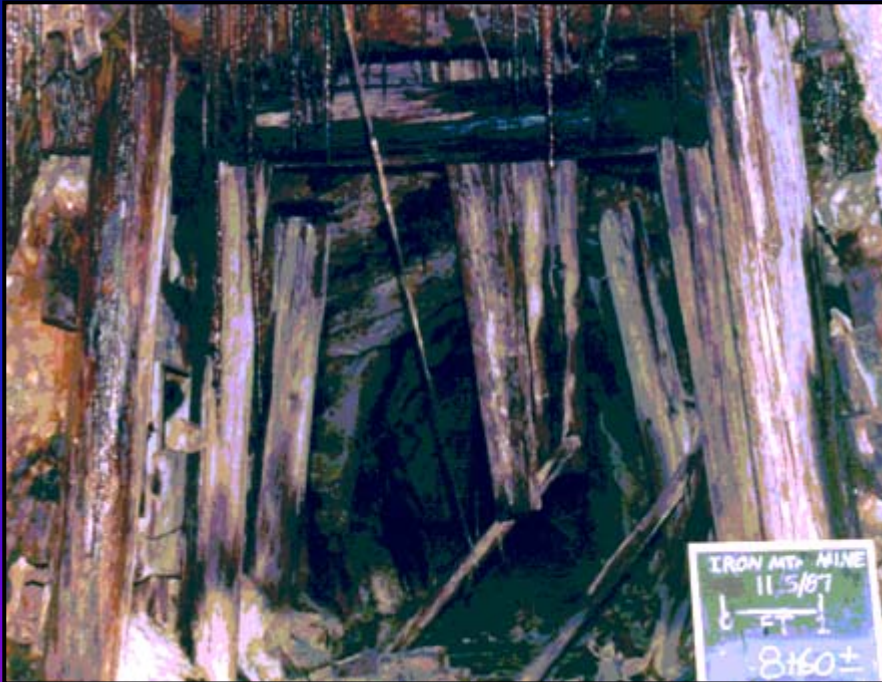
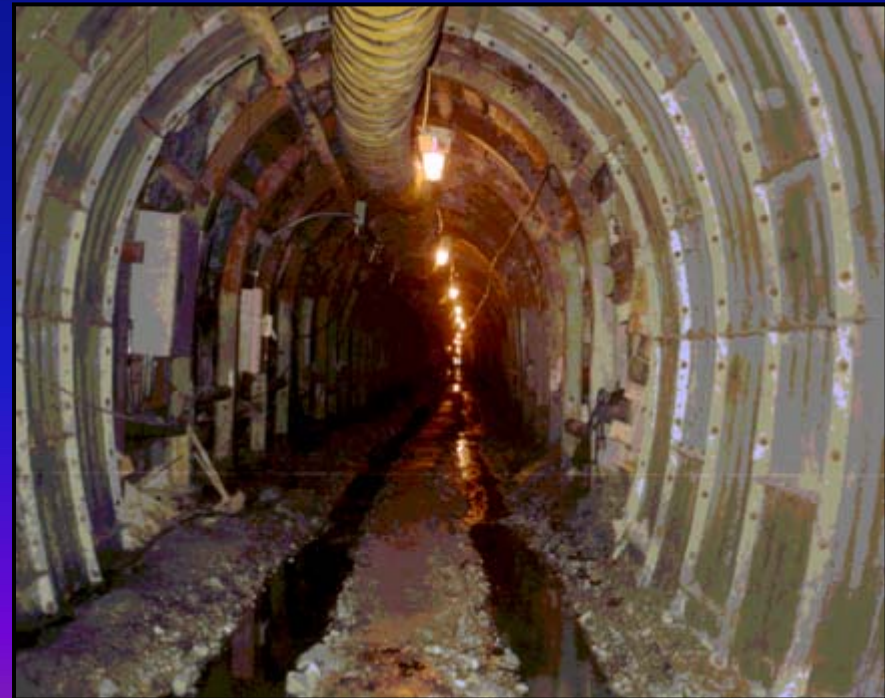
Richmond Adit Rehab

- ❑ \$1.2 million RD/RA for mine access
- ❑ Reconstructed 1,500 feet of Adit

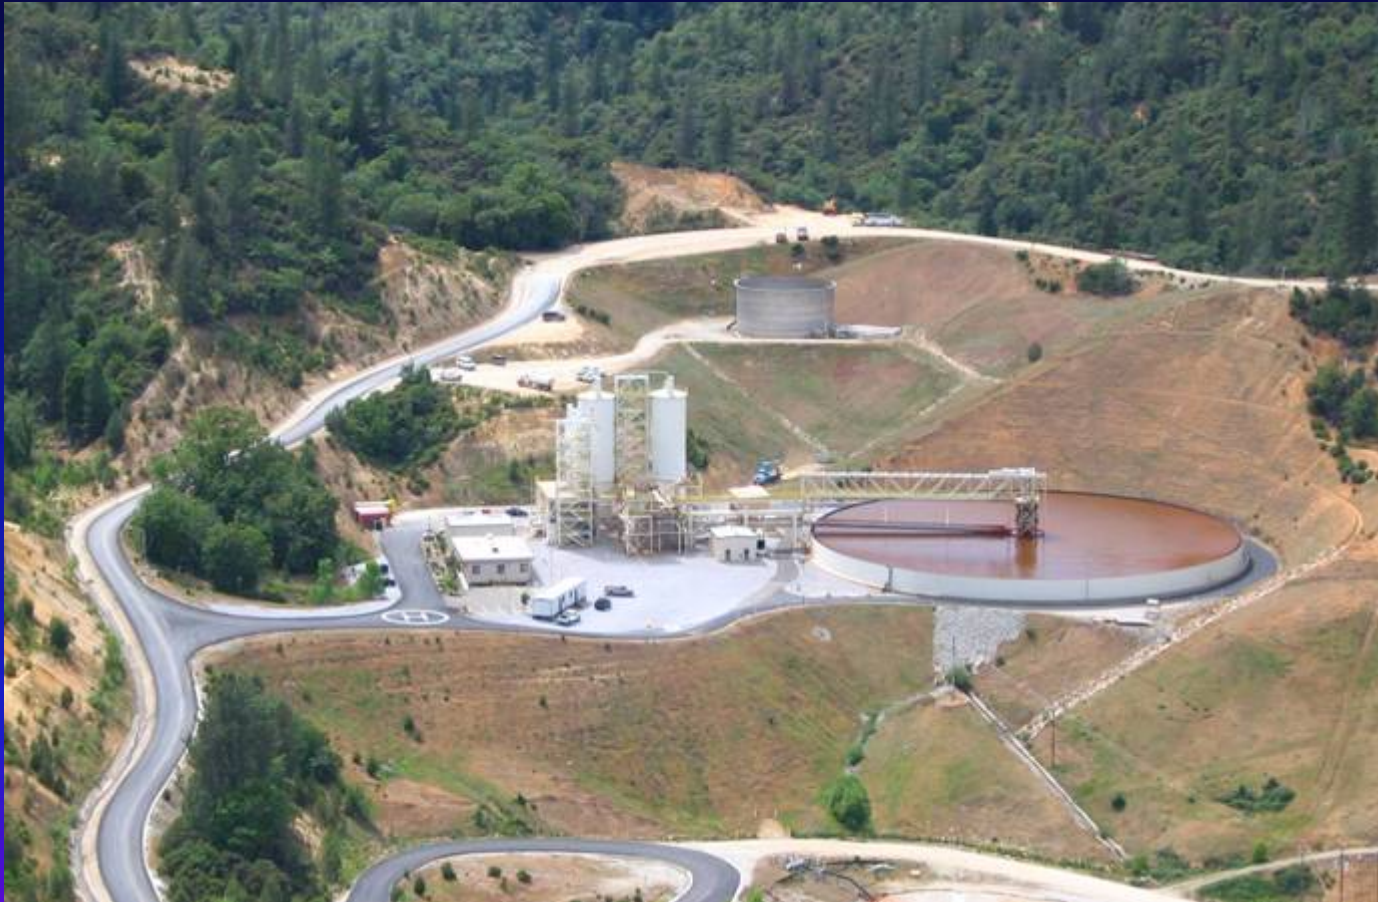
IMM Treatment Plant

HDS Treatment Process: Reduces Sludge Production and O&M Cost

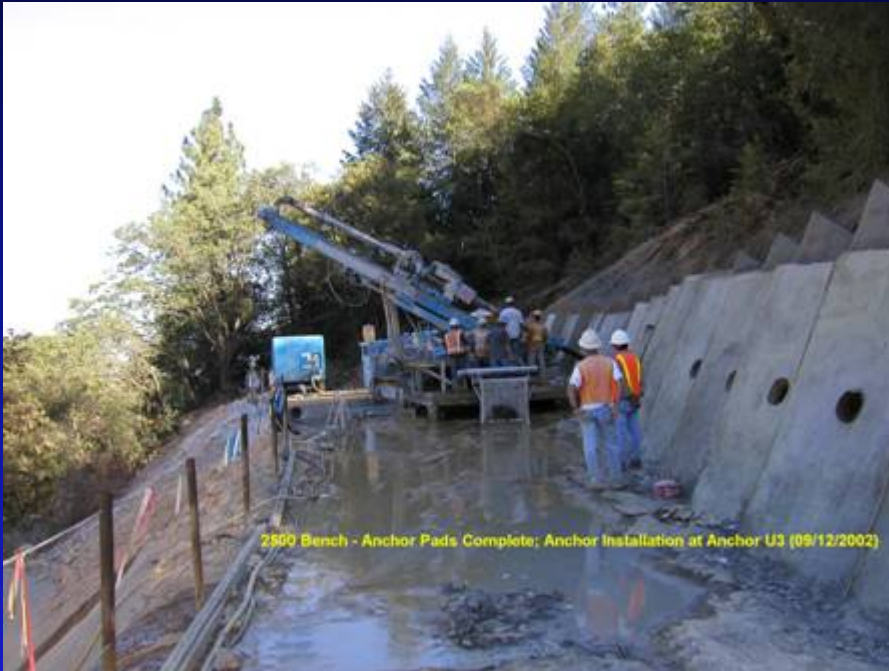
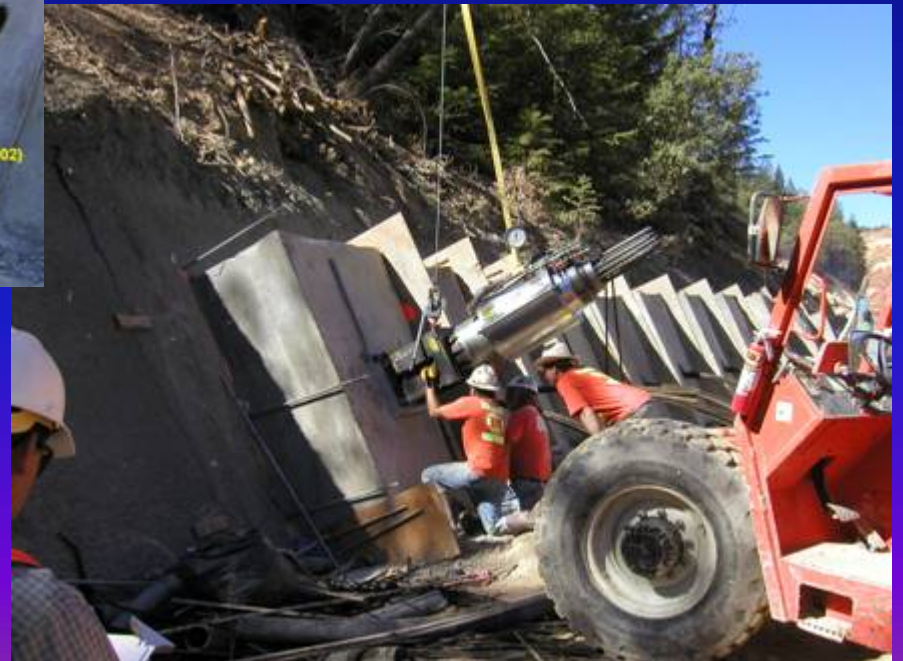
Slope Stabilization

**198 High Capacity Anchors
Each Stressed to 700 kips**

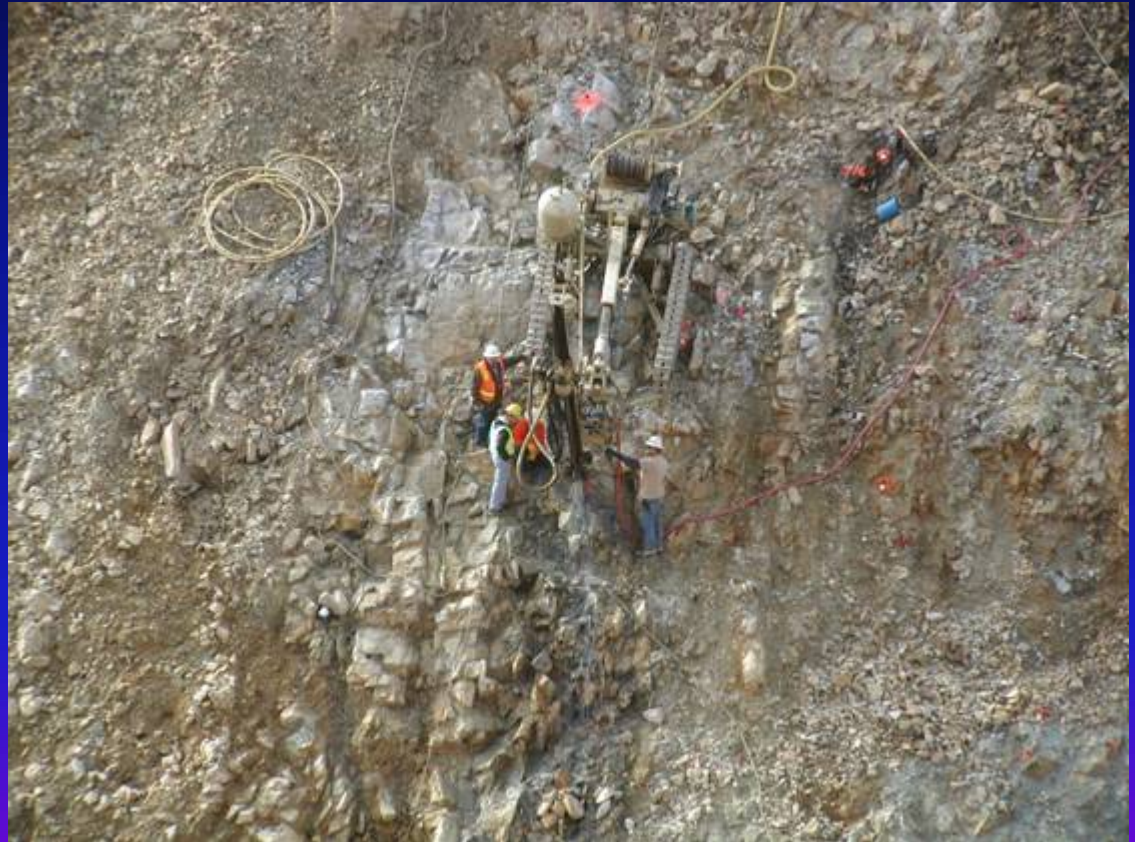
Foundation Grouting 2002 - 2003

25,400 ft grout holes
78,000 cu ft grout
118 tons cement

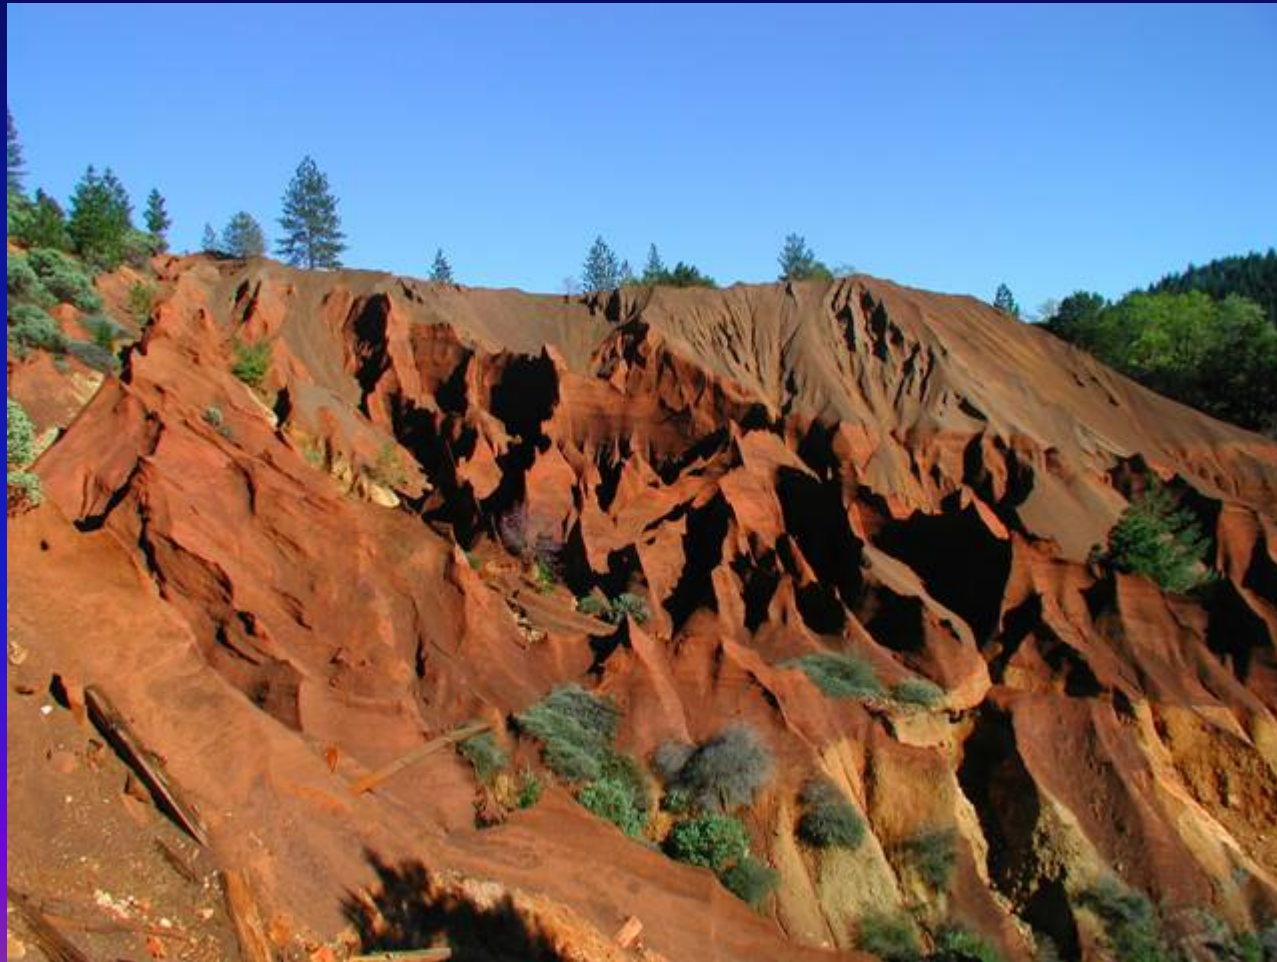
Gossan Tailings

High Arsenic Content

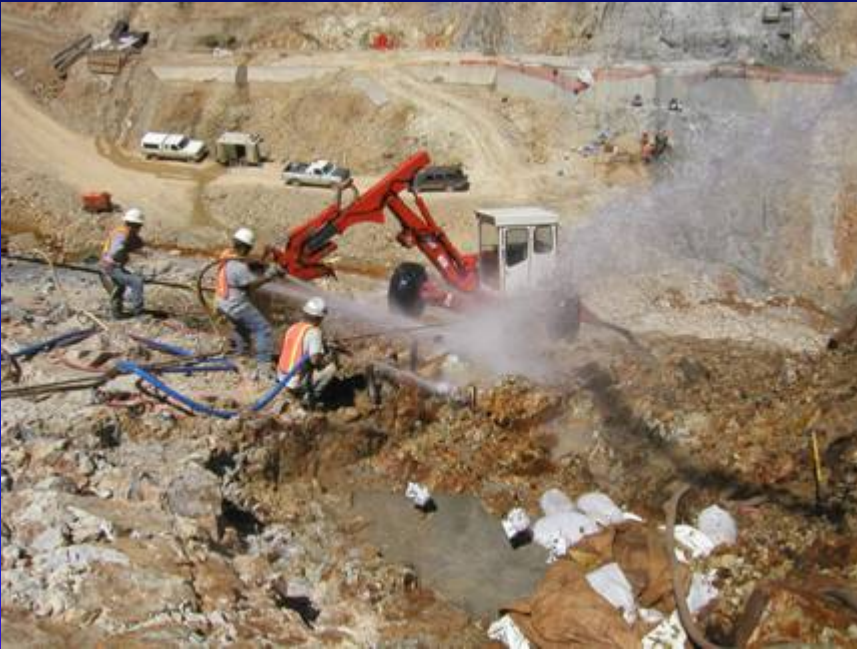
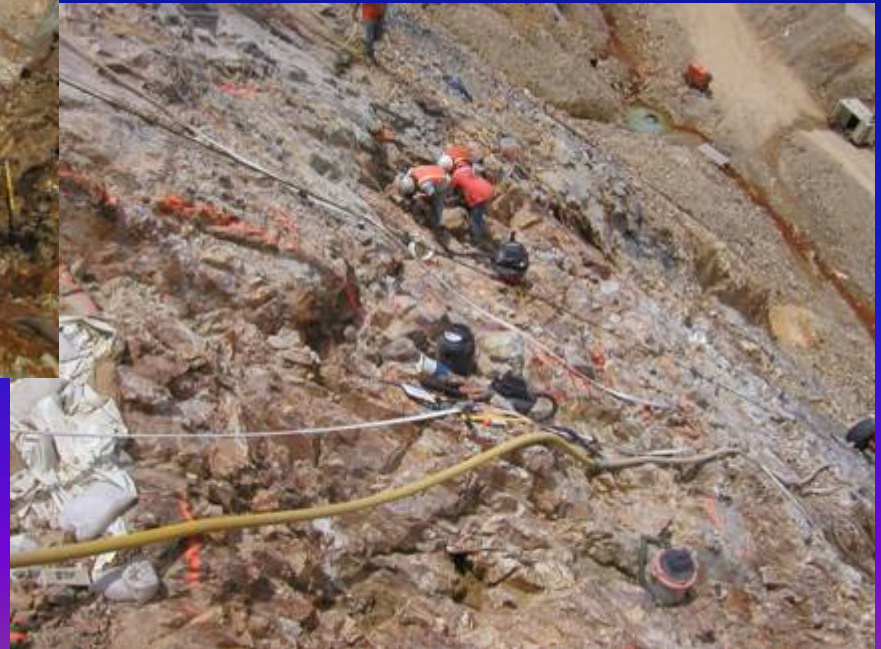
SCRR Foundation Prep

Excavation
Washing
Vacuuming

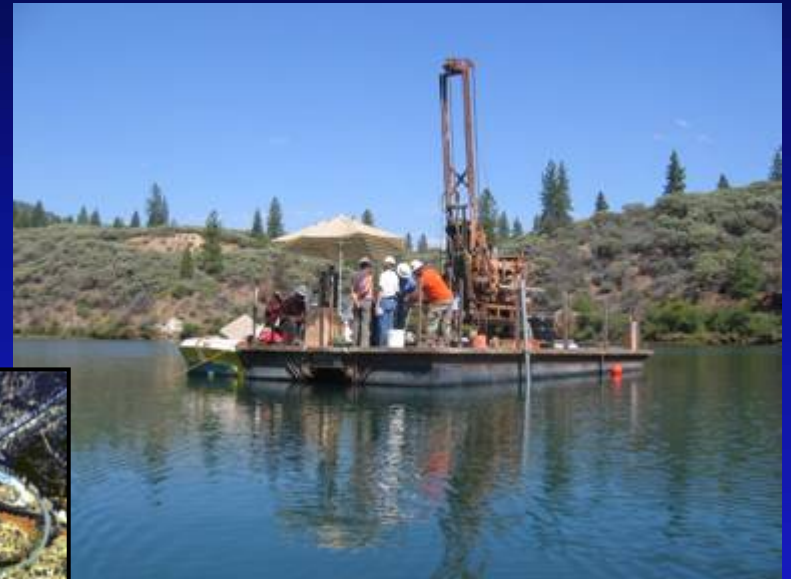
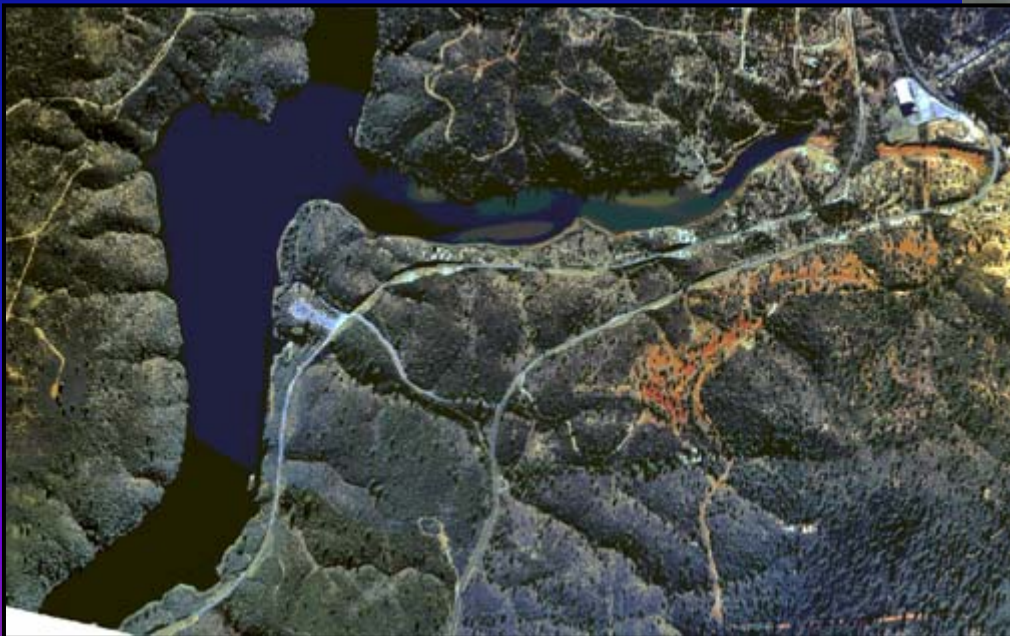
SCAKR Sediments RI/FS

300,000 CY Sediment Cleanup

- Bathymetry, Side Scan Sonar
- Field Investigation
- Toxicity/ Treatability Testing

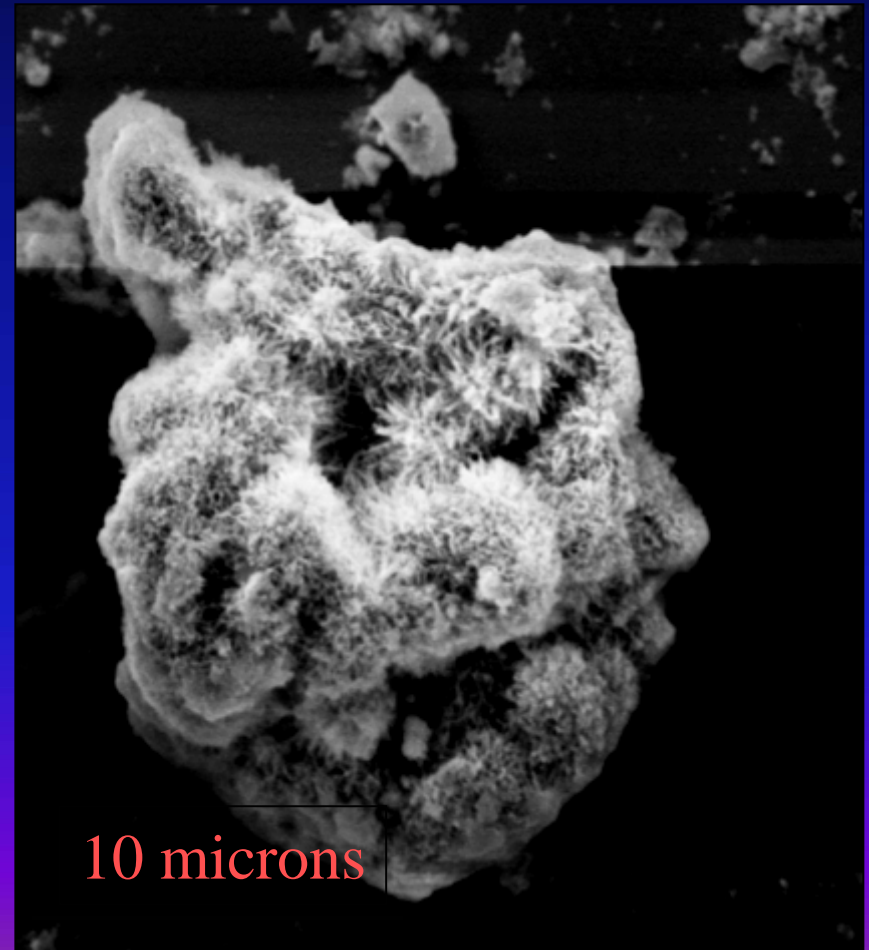
Oxyhydroxide Precipitates

Average Surface Area
21.5 - 69.6 m²/g

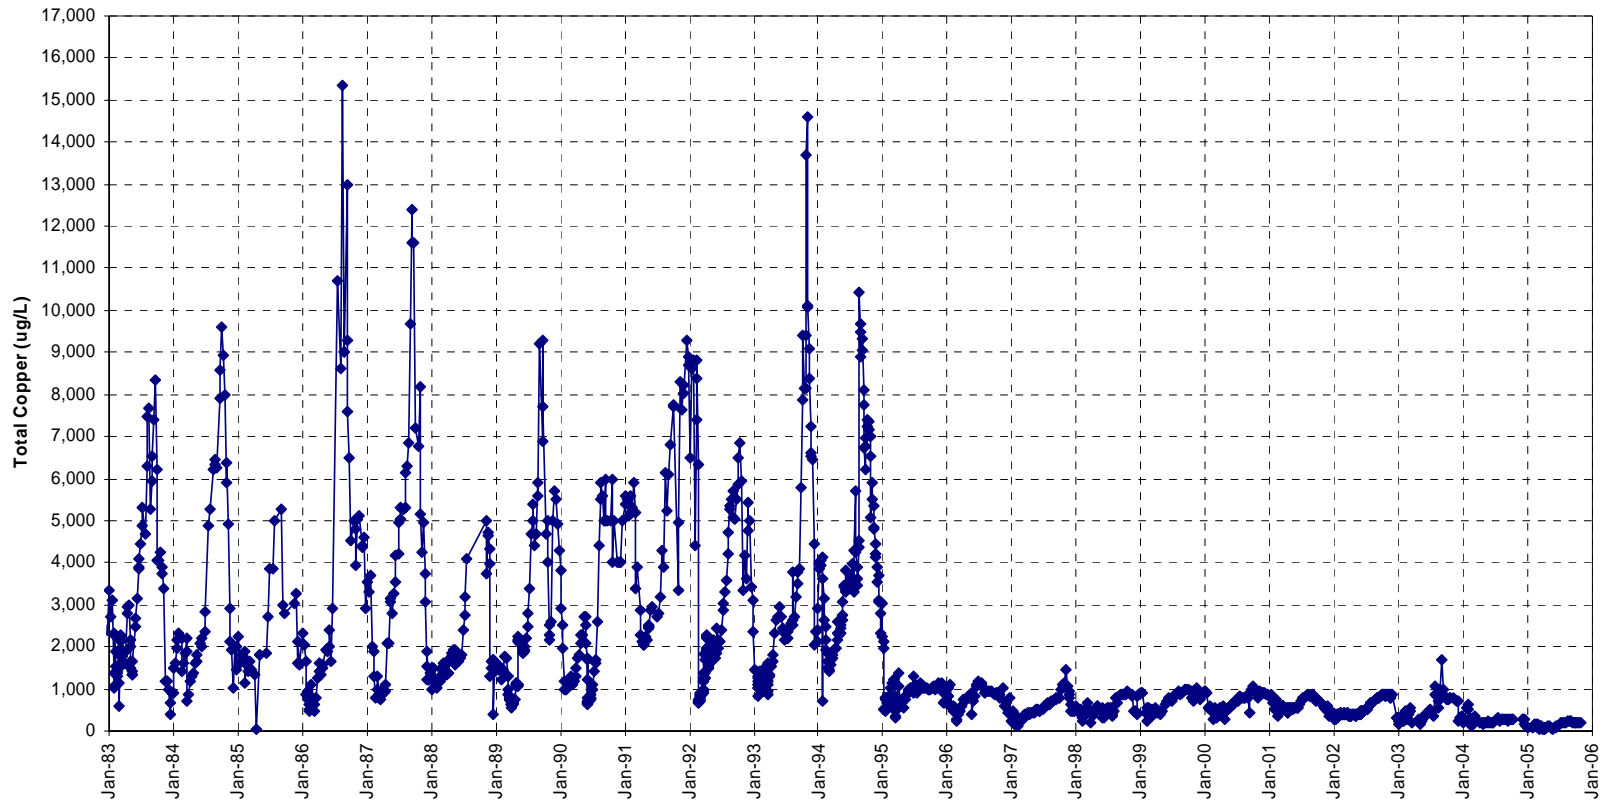
Spring Creek Debris Dam Discharge Copper Concentration

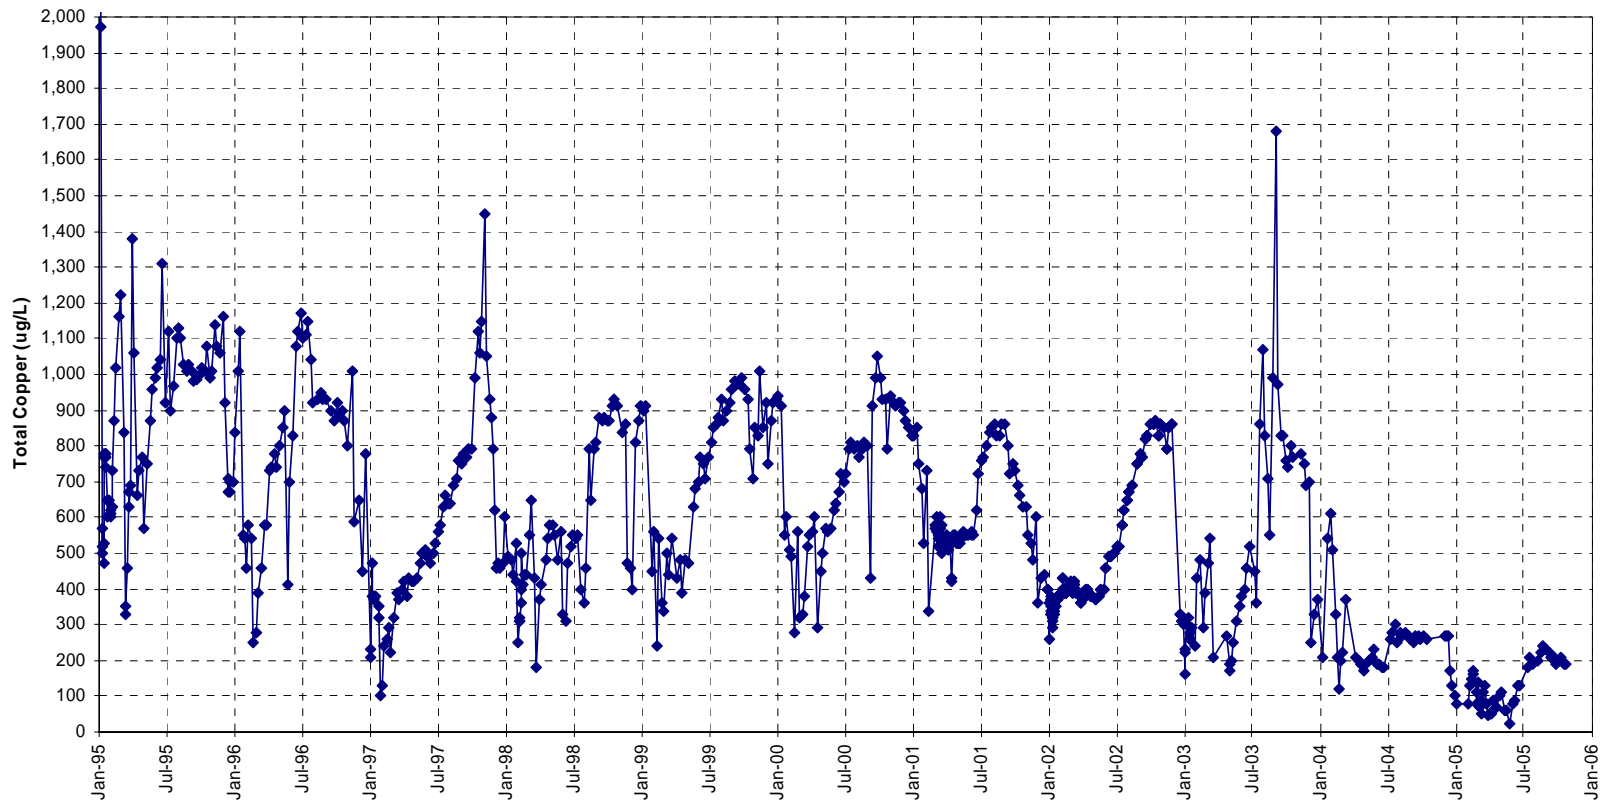
Spring Creek Debris Dam Discharge Copper Concentration
